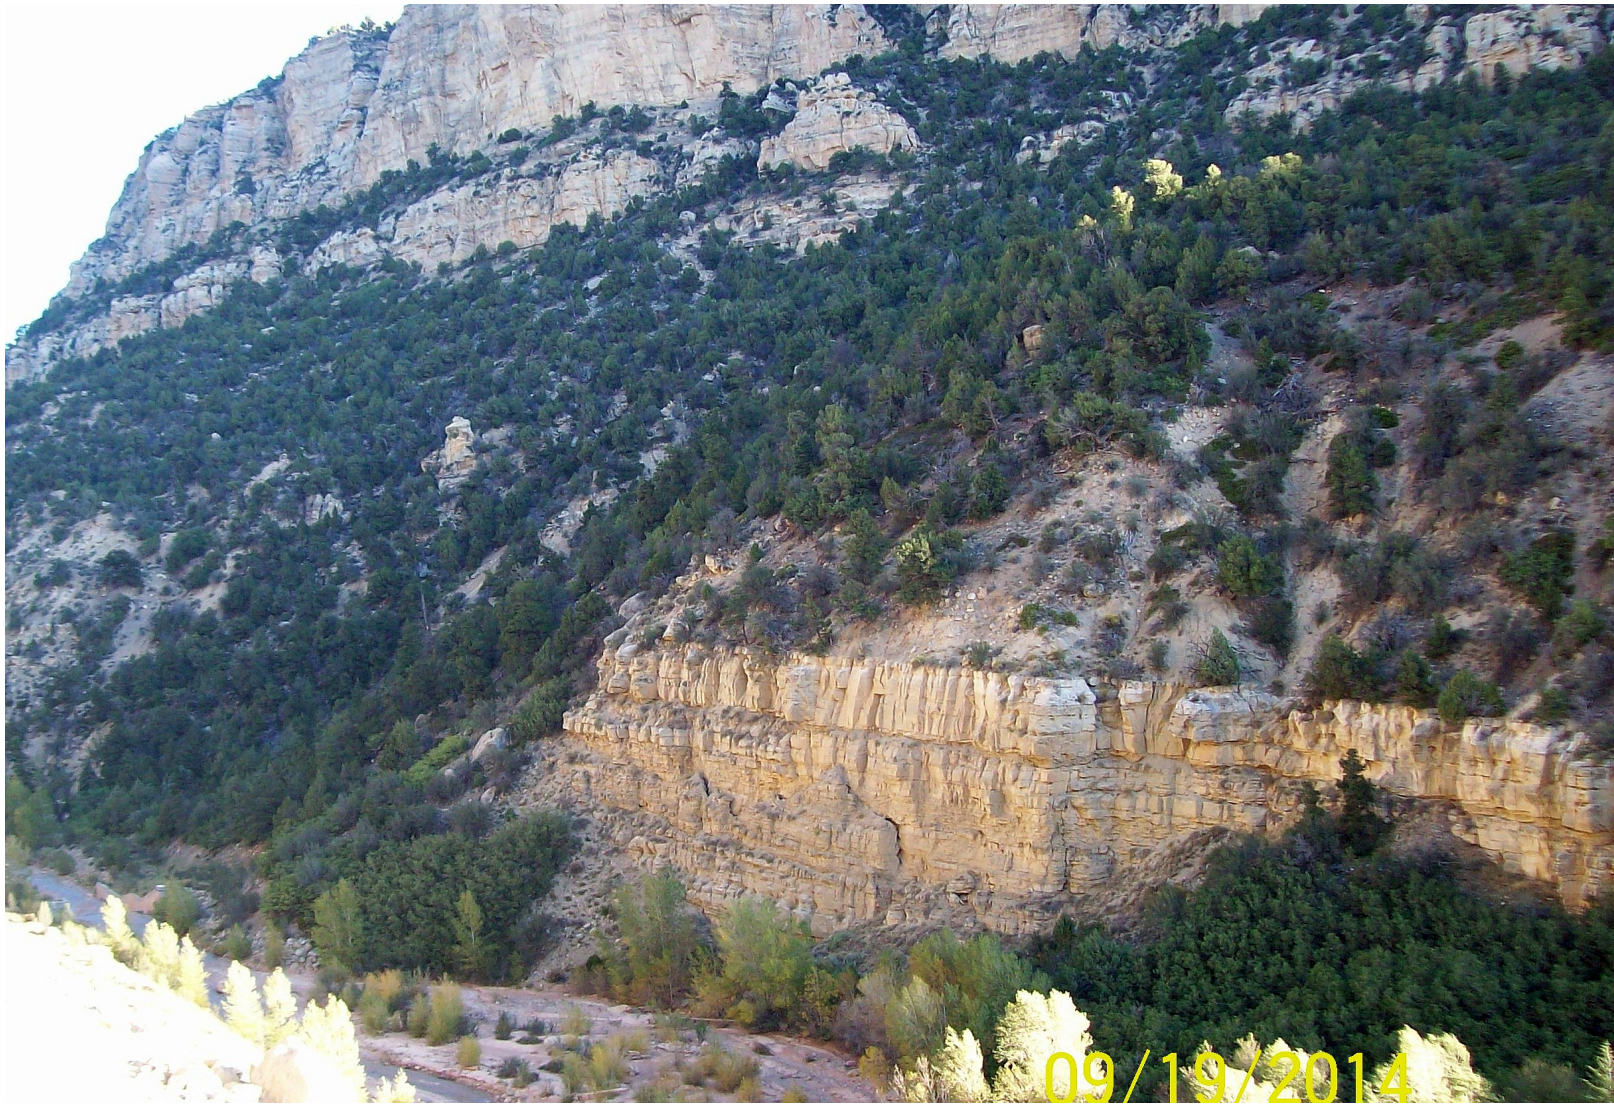
Fractured, porous, Cretaceous sandstones, probably best correlated with Straight Cliffs (above) and Dakota formations (below). Matrix porosities, measured in 2010, are about 20 percent, while the fractures probably add another 3 to 5 percent porosity. Exposures are just north of Utah Highway 14, east of Cedar City, and west of the landslide at mile 8. This is just west of the convergence of Ashdown and Crow creeks to form Coal Creek. These potential aquifer rocks are all present beneath Iron County's Woods Ranch Park, beginning about 200 feet below ground level.
